PROJECT ASSESSMENT REPORT			
Unique Document ID and Revision No:	ONR-CNRP-PAR-14-032 Revision 0	TRIM Ref:	2015/112518
Project:	Preliminary Investigation into the CO ₂ Release at Heysham 1		
Site:	Heysham 1		
Title:	Basis of enforcement decision following preliminary investigation into CO ₂ release at Heysham 1.		
Licence Instrument No: (if applicable)	N/A		
Nuclear Site Licence No:	60		
Licence Condition:	LC28

**Basis of enforcement decision following preliminary investigation into CO2 release at
Heysham 1**

Project Assessment Report ONR-CNRP.-PAR-14-032
Revision 0
24 March 2015

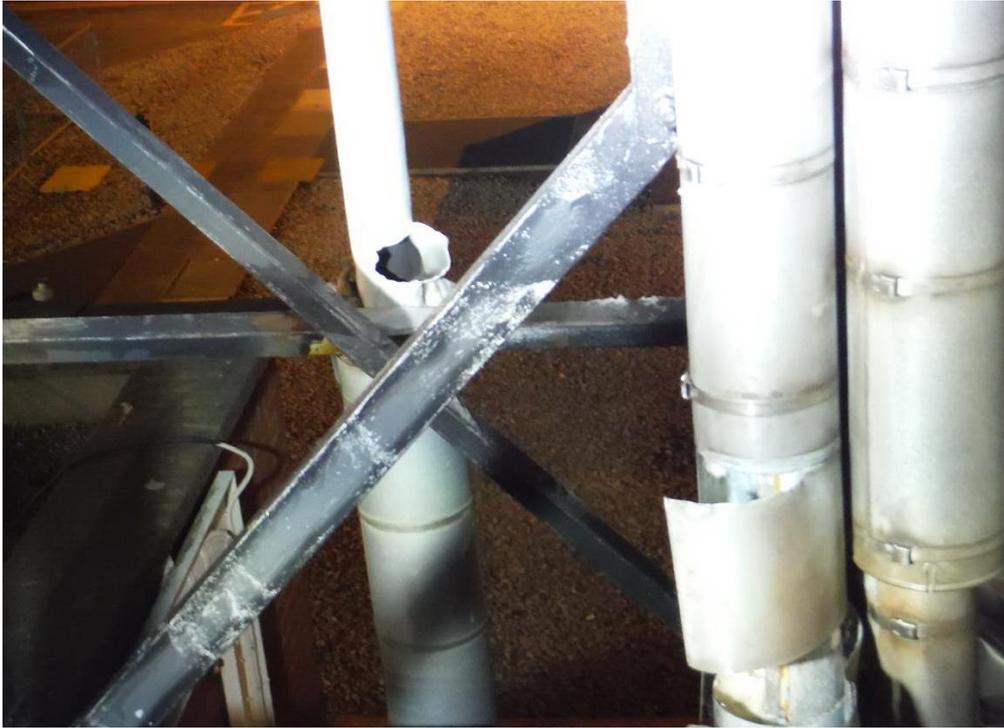
2. The leak was caused by a 3 inch diameter pipe failure in a pipe section between the High Pressure (HP) storage tank and the Pressure Sustaining Unit (PSU) which resulted in approximately 40 tonne of CO₂ being directly released to the atmosphere (See figures 1 and 2). The plant had been out of service for approximately eight months previously to enable maintenance and inspection work to be undertaken. The plant was in the process of being re-commissioned and had been re-pressurised as part of re-commissioning when the incident occurred.

24. The pipe failure is believed to be as result of corrosion under insulation (CUI) however this has yet to be confirmed. Degradation of the CO₂ plant pipework due to CUI had been identified during PSR2 as a known issue on the East and West CO₂ plants. A PSR Identified Corrective Action (PICA) item (4184) was raised for the site to conduct a full review, refurbish and repair programme to address concerns over fitness for duty (reference HYA/M/SSR/109 August 2011). During this programme, the section of failed pipe was identified in 2009 to have been inspected in 2006 and rated as 'good' and not to be inspected or replaced.

Figure 1: Photograph of the failed pipe taken after isolation of the CO₂ storage plant.

28. Given these findings I recommend that ONR issues an immediate Improvement Notice under LC28 to ensure that adequate maintenance is undertaken on the East CO₂ plant before it is brought back into service.

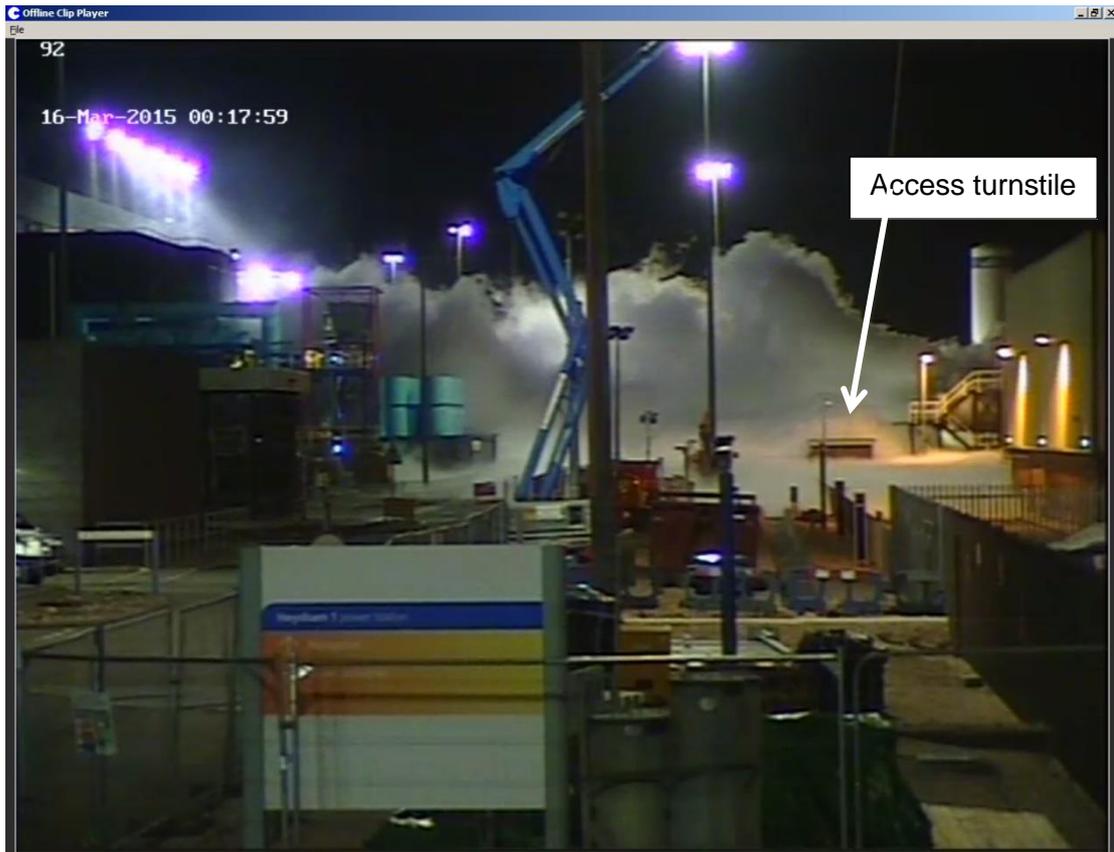
16. The main access/ingress route from Heysham 2 to Heysham 1 is via a pass controlled barrier at the far-east side of the East CO₂ plant approximately 8-10 meters from the release site (This is highlighted on Fig 2). This was also engulfed by the CO₂ vapour cloud.

17. Given the extent and speed of the CO₂ release it is ONR's judgement that if this event had occurred during the day, it is **probable** that there would have been **serious personal injury** to a number of these workers and probably fatal injuries from asphyxiation and/or from the toxicity of the CO₂. In addition, if the wind was blowing in the opposite direction, this could have seriously affected both the CNC and the half dozen or so staff working further upstream of the release.

Figure 2: Still screen grab taken from the security camera video footage showing the extent of the CO₂ release and the affected area.
