PROJECT ASSESSMENT REPORT			
<b>Unique Document ID and Revision No:</b>	ONR-SZB-PAR-17-013 Revision 1	<b>TRIM Ref:</b>	2018/55754
<b>Project:</b>	Sizewell B Periodic Shutdown 2017 (Refuelling Outage 15)		
<b>Site:</b>	Sizewell B		
<b>Title:</b>	EDF Energy Nuclear Generation Limited (NGL) – Sizewell B – Consent under Licence Condition 30(3) to start-up the reactor following periodic shutdown.		
<b>Licence Instrument No:</b> (if applicable)	LI 553		
<b>Nuclear Site Licence No:</b>	63		
<b>Licence Condition:</b>	30(3)

**Sizewell B – Periodic Shutdown 2017 (Refuelling Outage 15)**

**EDF Energy Nuclear Generation Limited (NGL) – Sizewell B - Consent under Licence  
Condition 30(3) to start-up the reactor following periodic shutdown.**

Project Assessment Report ONR-SZB-PAR-17-013  
Revision 1  
January 2018

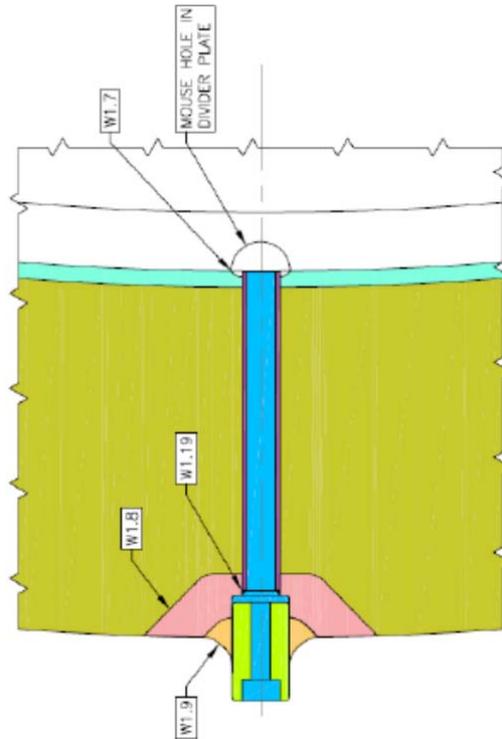
**Figure 1 - Steam Generator Drain Region Layout and Welds**

84. Weld W1.9 was confirmed as the site of the leak site detected on steam generator D. However, further inspections identified radial defects in all four steam generator drain line weld pads (W1.8) caused by primary water stress corrosion cracking (PWSCC). Further inspections found that no other welds associated with the drain line connection (or the channel head) were defective.

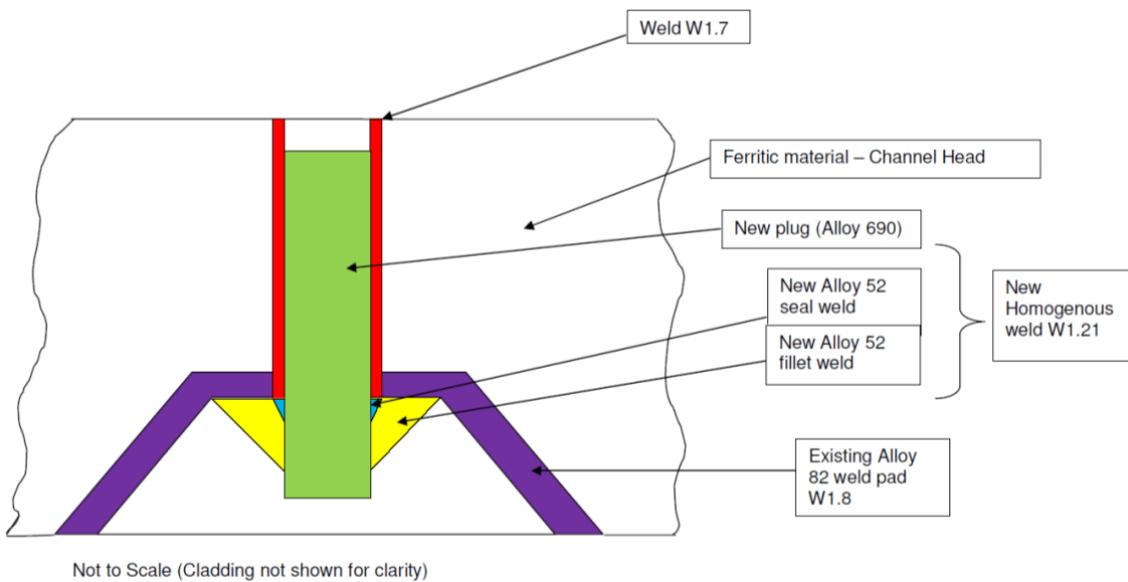
**Figure 2 - Steam Generator Drain Line Repair**

85. Dye penetrant examinations at stages during the machining processes determined that cracking of weld W1.8 was limited and the defective material was removed. With at least 5mm of weld W1.8 remaining, NGL decided to implement a non-complex plug repair on all four SGs (see Figure 2).

88. The inspector was satisfied that the repair method chosen by NGL was suitable and had been subject to the appropriate scrutiny through established company processes. He was also satisfied by the testing and qualification work performed to ensure that the repair was performed to a high standard. The inspector has reviewed the evidence supporting removal of the drain line and was satisfied that it was unlikely to adversely affect the operation or safety of the reactor.

89. The repair is presently limited to two cycles of operation and NGL have committed to a number of work packages to provide further evidence to support the continued operation of the drain line. The inspector judged that the current safety case was sufficient for two cycles of operation and that for long term operation (post two cycles) the commitments were sufficient to address long term uncertainties.
