**Report of the investigation into the leak of
dissolver product liquor at the Thermal Oxide
Reprocessing Plant (THORP), Sellafield, notified
to HSE on 20 April 2005**

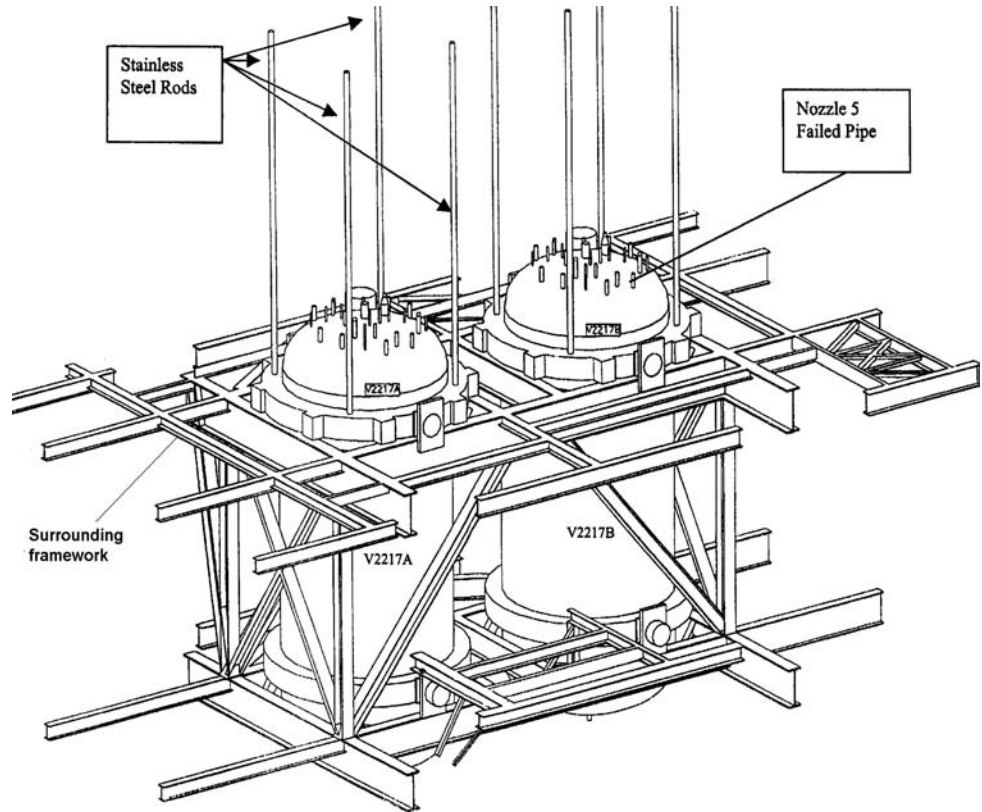
Figure 1 Line drawing of accountancy tanks V2217A and V2217B, hanger rods and surrounding framework

99 The support arrangement (see Figure 1, paragraph 23) for each of the accountancy vessels V2217A and B consists of four rods which at their top ends connect to a weigh table in a room above Cell 220. The lower ends of the rods connect to a support ring, which is part of the vessel fabrication. The support ring is located about 1.2 m below the top-most point of the vessel (the crown of the top of the vessel). It is important to note that although the accountancy vessels are surrounded by a substantial mild steel framework (Figure 1), in normal operation the vessels are not supported by this framework.

100 BNGSL realised during its investigations following the failure that under certain operational conditions the accountancy vessels can move in a horizontal direction, ie they can swing or sway on the support rods. In effect, the rods and vessel form a rotational pendulum. The operational conditions arise when the accountancy vessel has liquor in it and the liquor is being agitated, or agitated and emptied. The agitation is required in normal operation to homogenise the liquor to obtain accurate accountancy results and also to prevent solids settling out. The method of agitation involves several small vessels within the accountancy vessels being alternately filled and emptied. Changes in fluid flow momentum during these processes cause overall motion in the accountancy vessel.
