**Report of the investigation into the leak of
dissolver product liquor at the Thermal Oxide
Reprocessing Plant (THORP), Sellafield, notified
to HSE on 20 April 2005**

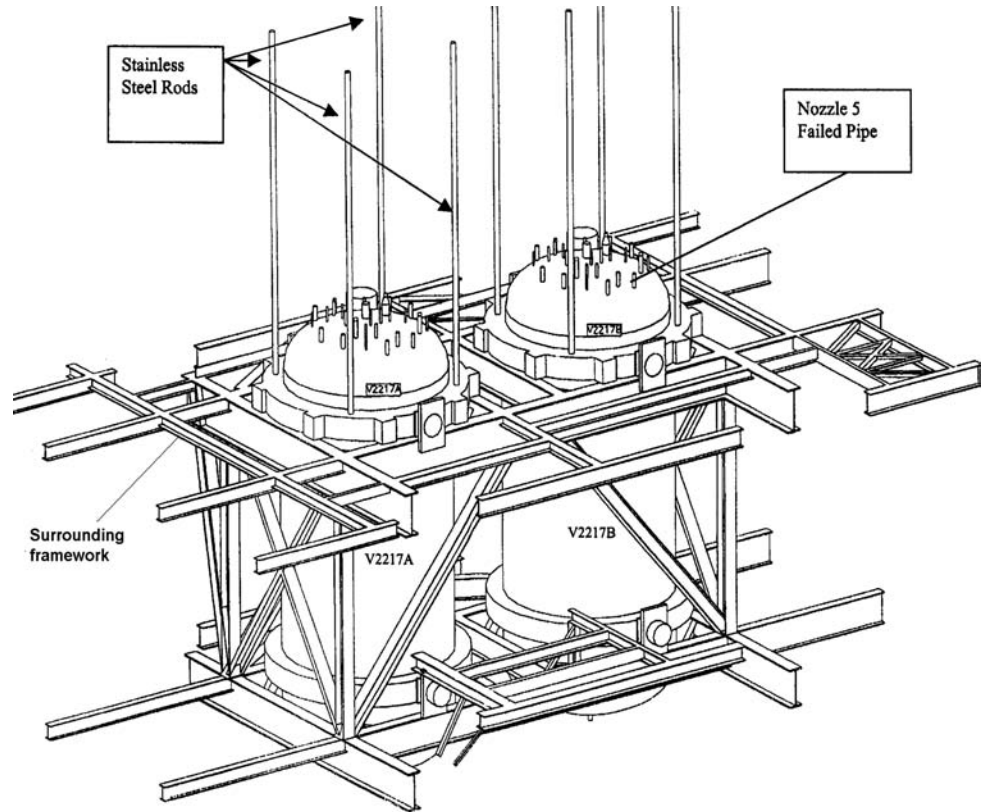
Figure 1 Line drawing of accountancy tanks V2217A and V2217B, hanger rods and surrounding framework

99 The support arrangement (see Figure 1, paragraph 23) for each of the accountancy vessels V2217A and B consists of four rods which at their top ends connect to a weigh table in a room above Cell 220. The lower ends of the rods connect to a support ring, which is part of the vessel fabrication. The support ring is located about 1.2 m below the top-most point of the vessel (the crown of the top of the vessel). It is important to note that although the accountancy vessels are surrounded by a substantial mild steel framework (Figure 1), in normal operation the vessels are not supported by this framework.

100 BNGSL realised during its investigations following the failure that under certain operational conditions the accountancy vessels can move in a horizontal direction, ie they can swing or sway on the support rods. In effect, the rods and vessel form a rotational pendulum. The operational conditions arise when the accountancy vessel has liquor in it and the liquor is being agitated, or agitated and emptied. The agitation is required in normal operation to homogenise the liquor to obtain accurate accountancy results and also to prevent solids settling out. The method of agitation involves several small vessels within the accountancy vessels being alternately filled and emptied. Changes in fluid flow momentum during these processes cause overall motion in the accountancy vessel.

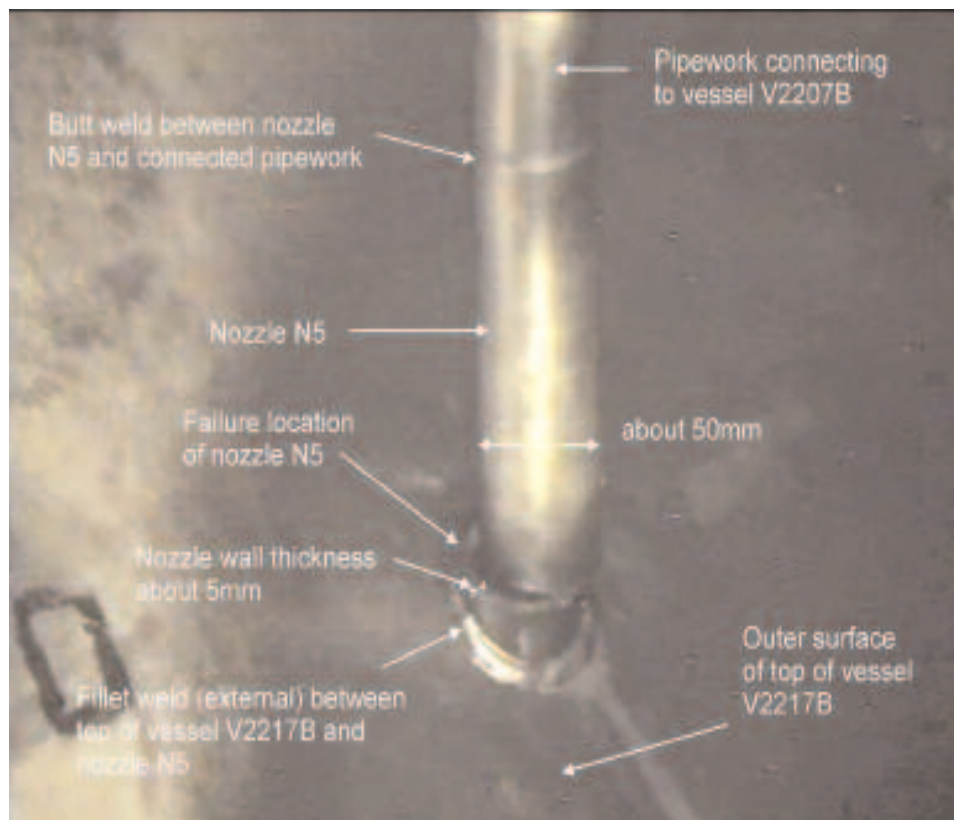
3 Video evidence indicated that the leak came from a pipe, identified as nozzle N5, which had completely severed at a point just above where it enters accountancy tank B (HEAT B - Head End accountancy tank V2217B). The most likely cause was fatigue failure from the swinging or swaying motion of the suspended tank, which occurred during agitation of the tank contents as part of normal operation. The motion occurred because of design inconsistencies in the later stages of the design process and during construction, together with a modification to the operational mode of the vessel around 1997, which inadequately considered the impact on pipework. The change process overlooked the effects of the tanks swinging on their suspension rods during agitation of liquor, leading to pipework fatigue.

98 The HSE investigation concluded that leakage of process liquor from the primary containment in THORP FCC occurred from a failure of nozzle N5 in the top of HEAT B (V2217B). The cross section of nozzle N5 was completely severed at a point just above where it enters the HEAT (see Figure 2) The most likely type of failure of nozzle N5 of HEAT B is fatigue failure due to the motion of the vessel on its rods during certain conditions of operation. HSE also concluded that initially the breach area would have been small and would only have grown to a complete guillotine failure in the later stages.

Figure 2 Failed nozzle 5 on HEAT B

101 A video of the behaviour of HEAT accountancy vessel A taken as part of the BNGSL investigation showed that there is imperceptible movement when the vessel is full but very visible and large movements of the vessel in the horizontal plane when it is half full. This horizontal movement of the vessel can be seen to move the connections to it, including nozzle 4, that nozzle that has the same function as the failed nozzle 5 on HEAT B.
