PROJECT ASSESSMENT REPORT			
Unique Document ID and Revision No:	ONR-OFD-PAR-17-003 Revision 0	TRIM Ref:	2017/176884
Project:	Agreement to the modification of the optimisation of inspection requirements on superheater outlet and reheater inlet steam side header welds		
Site:	Dungeness B		
Title:	Agreement to the modification described in Safety Case NP/SC 7749 to Optimise the Inspection Requirements of Welds within the Superheater Outlet Headers and Reheat Inlet Headers on Reactor 21 and Reactor 22 at Dungeness B (Excluding R21 SHO Headers B3 and B8)		
Licence Instrument No: (if applicable)	Agreement 553		
Nuclear Site Licence No:	61		
Licence Condition:	22(1)

Assessment of the optimisation of inspection requirements on superheater outlet and reheater inlet steam side header welds

Agreement to the modification described in Safety Case NP/SC 7749 to Optimise the Inspection Requirements of Welds within the Superheater Outlet Headers and Reheat Inlet Headers on Reactor 21 and Reactor 22 at Dungeness B (Excluding R21 SHO Headers B3 and B8)

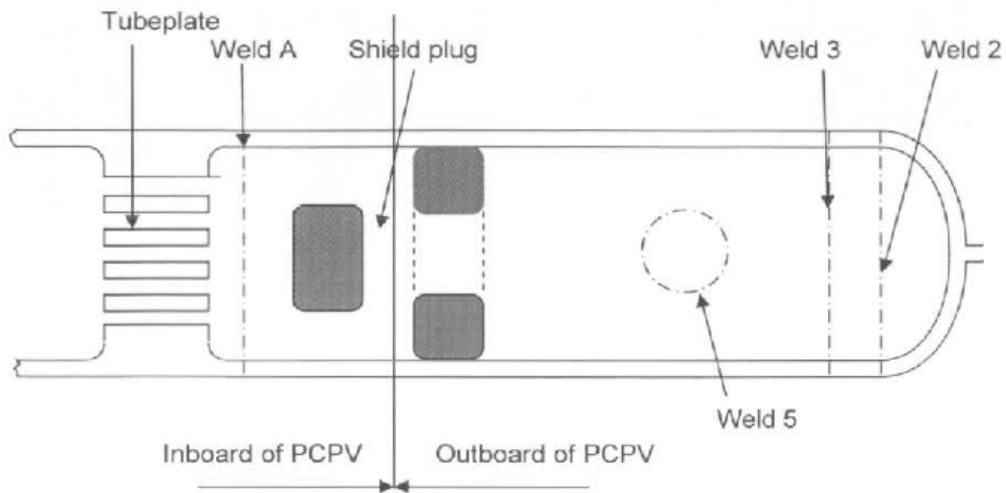
Figure 2 - Superheater outlet header

Location of the Steam Side Welds in the Superheater Outlet (Main Steam) Header

2. Dungeness B has two advanced gas reactors, designated Reactor 21 and Reactor 22. Each reactor has eight superheater outlet (SHO) header penetrations (Figure 1), which provide superheated steam from the boilers to the turbine. They are large welded cylindrical stainless steel vessels (Figure 2). In 1999, routine inspections undertaken by the licensee, EDF Energy Nuclear Generation Limited (NGL), identified a fully circumferential crack in a weld (designated Weld 'A' on Figure 2) on the inside surface of SHO header penetration labelled "B3" (Figure 1) on Reactor 21.

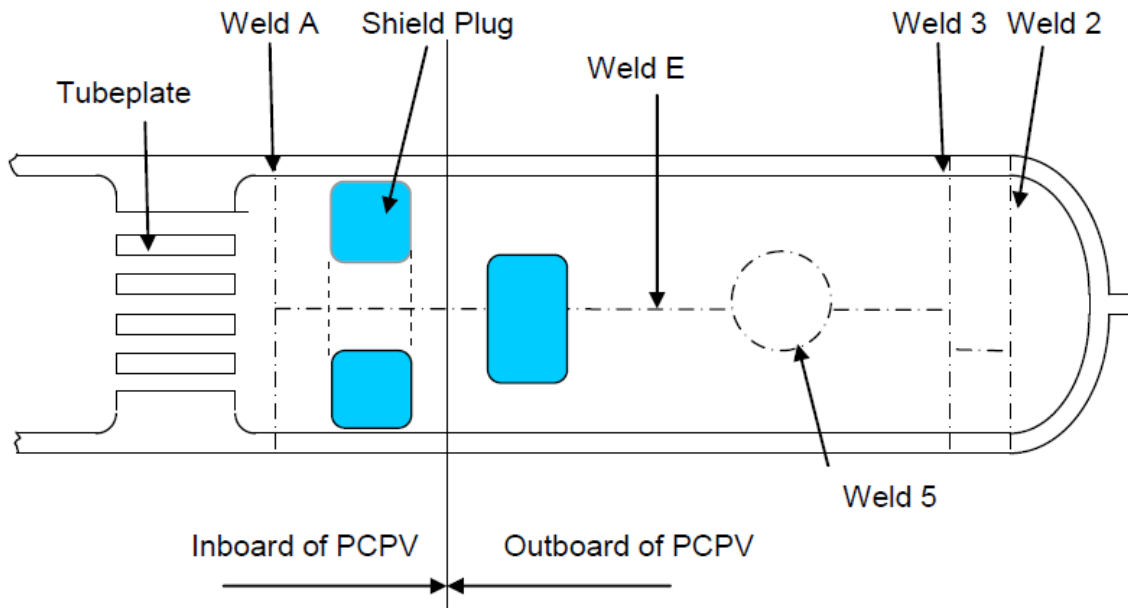
Figure 3 - Reheater inlet header

Location of the Steam Side Welds in the Reheater Inlet (Cold Reheat) Header
